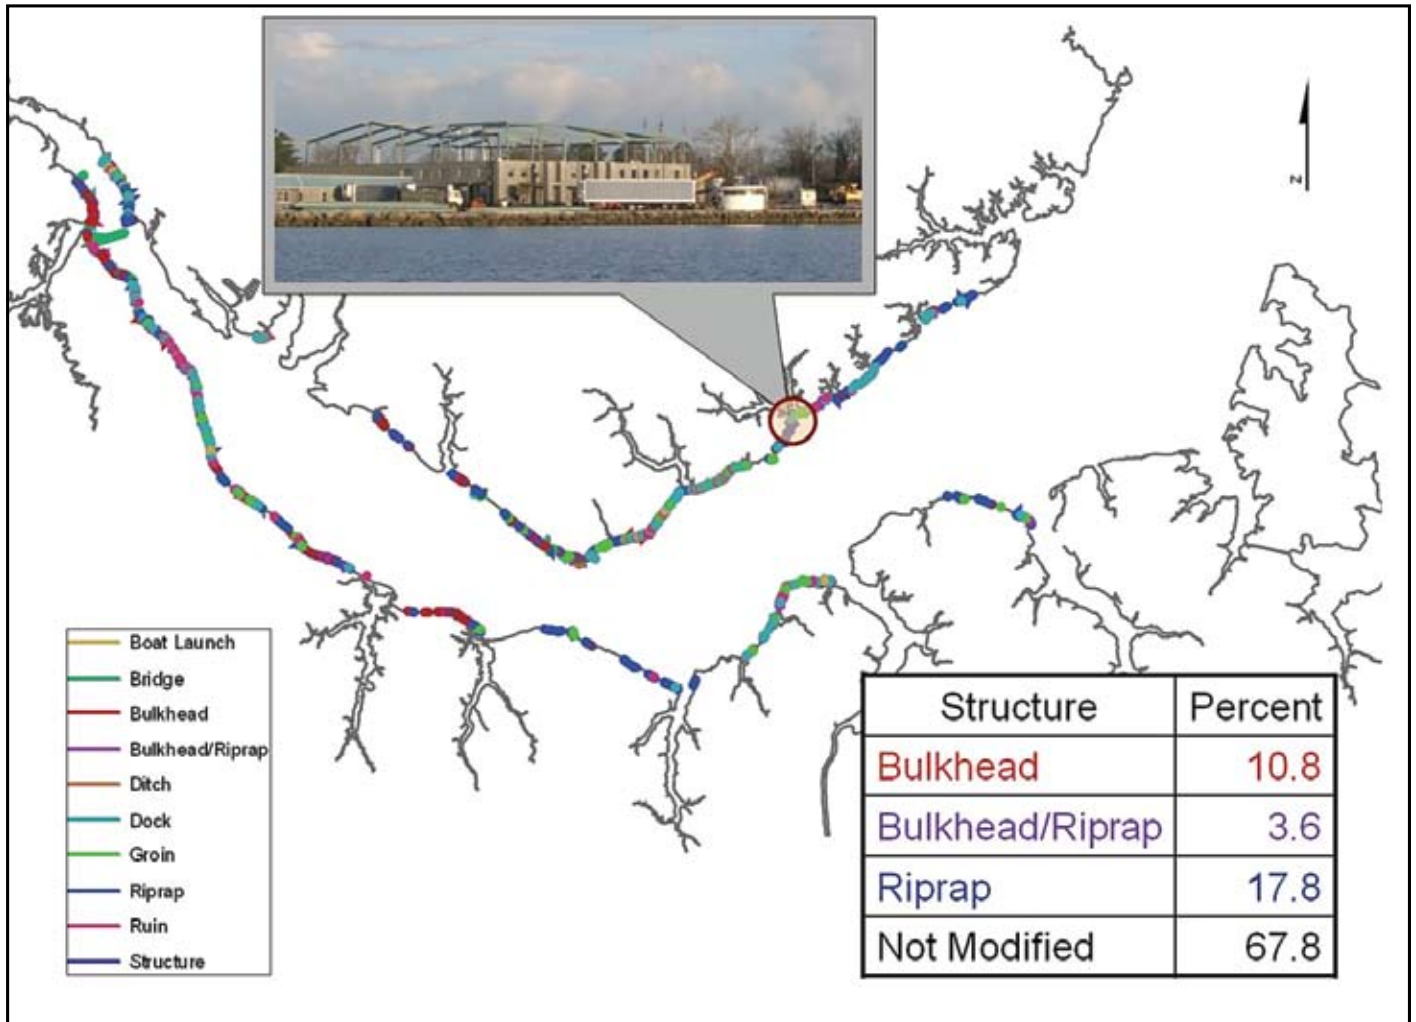
Figure 6. Modified shorelines along the trunk of the Neuse River Estuary in December 2007. The inset is an example of a shoreline stabilized with riprap along the Oriental waterfront.
